Watershed Survey Report And Action Plan

LAKE BOON
Hudson & Stow, MA

May 2003

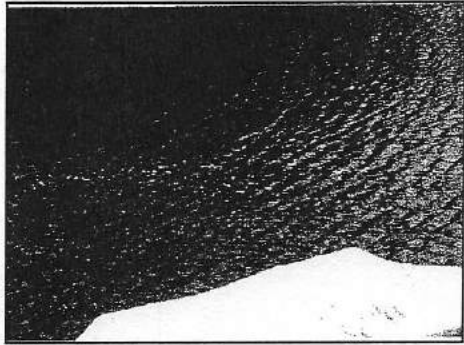
Note: We had also observed larger amounts of foaming in the waters of the first basin and the narrows after the 6/2002 herbicide application to the lake.

Foam in lake, Section 2

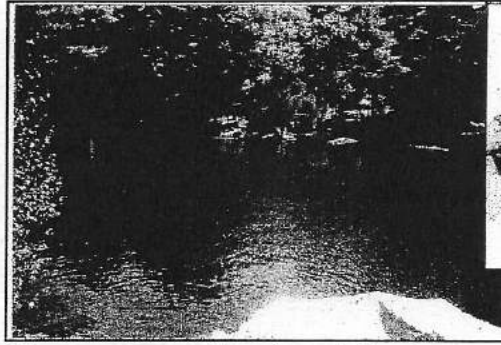
Note: We had also observed in September/October 2002 large masses of dead and live weeds migrating from the 3rd and 4th overflow flood basins through the narrows and into the 1st basin. This was a result of the 6/6/2002

herbicide application to Lake Boon. There were approximately 30+ large weed masses with dead and live weeds (mostly Cabomba/Fanwort) observed during day hours with additional masses during evening hours as well. Note also that the first basin, the narrows and the majority of the 2nd basins do not have these weeds growing as they are considerably deeper (10' to 30') than the 2' to 8' deep 3rd and 4th overflow flood basins. The concern is that these weed masses will contribute to the shallowing of the 1st basin depth and may also create new growths of these weeds in the 1st and 2nd basins and the narrows where there was no weed growth before. This would further exacerbate weed proliferation throughout the lake and further accelerate the culturally induced eutrophication process.

Plant masses traveling through Sec 2

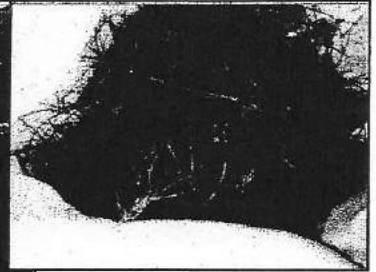
Close-up of plant mass

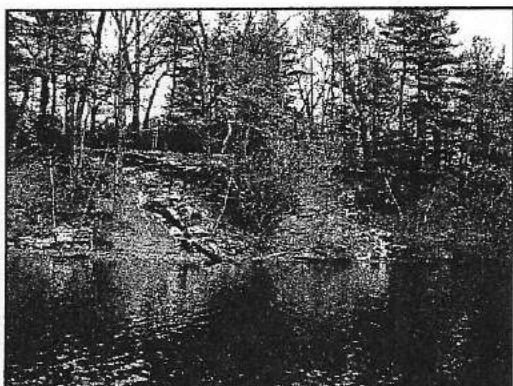
Section 1 - Stow Town Beach Area

- **Shoreline Sections:** 1, 2, 8 & 9
- **Observation:** Extensive erosion resulting from inadequate retaining walls and lack of proper vegetation on private property, as well as abusive recreational activity from foot traffic, dirt bikes, ATVs, snowmobiles, motorboats, etc. on lake and the town beach areas

Erosion north of Town beach -
Remains of rope swing at site

- c. Take down tree swings.
 - d. Inform homeowners regarding appropriate design, construction, and maintenance of retaining walls to minimize run-off and erosion (raised lip along edge to divert rainfall; contours to dissipate boat wake energy, etc.). Provide information to homeowners about the importance of retaining or re-planting trees, shrubs, and groundcovers on shorelines for erosion control. Educate lake users about concerns regarding high motor boat use causing significant erosive damage (wake boarding, water and jet skiing)

- a) Section 1 – road damage above the beach
 - b) Steep hillsides north and south of the beach are eroding – stabilize shoreline and hillside
Section 10 – erosion problems at the “dog beach”

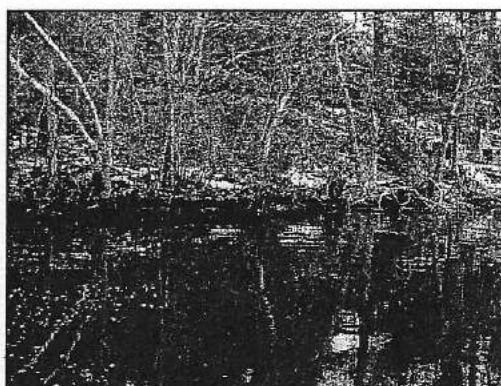
Black plastic along shoreline north of
Town beach

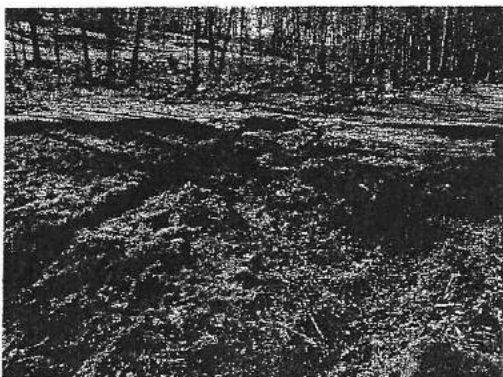
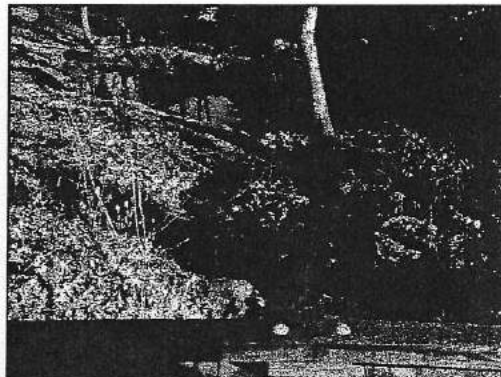
Section 5 - Golf Course

To the south and at the end of the area we surveyed, there is a golf course and an abandoned railroad track. A drain pipe coming from the golf course was found. Water appeared to be coming from the golf course into the stream.

Stream running through Golf Course

- a) Section 5 - Concerns of water quality impacts to tributary from the golf course.
- Golf course is supposed to be monitoring the tributary - get monitoring data from golf course
 - See that orders of conditions regarding impacts to the tributary are being enforced.
 - Follow up on monitoring to ensure that schedule is followed.
- b) Section 4 & 5 - Investigate stormwater impacts to tributary from the Industrial Area
Dick Gelpke & Lori Hawkes will write letters.

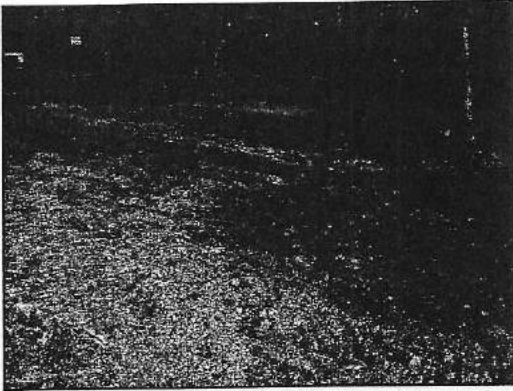
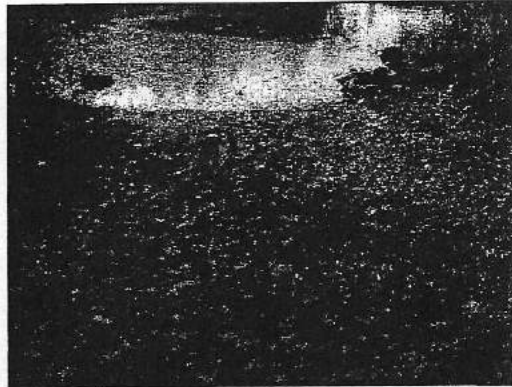
Sections 7 & 8 (3rd & 4th Basins)

1. Road runoff at the Sudbury Rd. public access (boat launch site)
2. Road runoff from the end of Dawes Rd. down the right of way into the lake
3. Variable-leaf Milfoil was found in the 4th Basin nearest the Town Line area

Road Runoff & Erosion - Sudbury Rd. Public Access
