AQUATIC PLANT MANAGEMENT
LAKE BOON
STOW/HUDSON, MASSACHUSETTS
BIOLOGICAL SURVEY REPORT
JUNE 2006

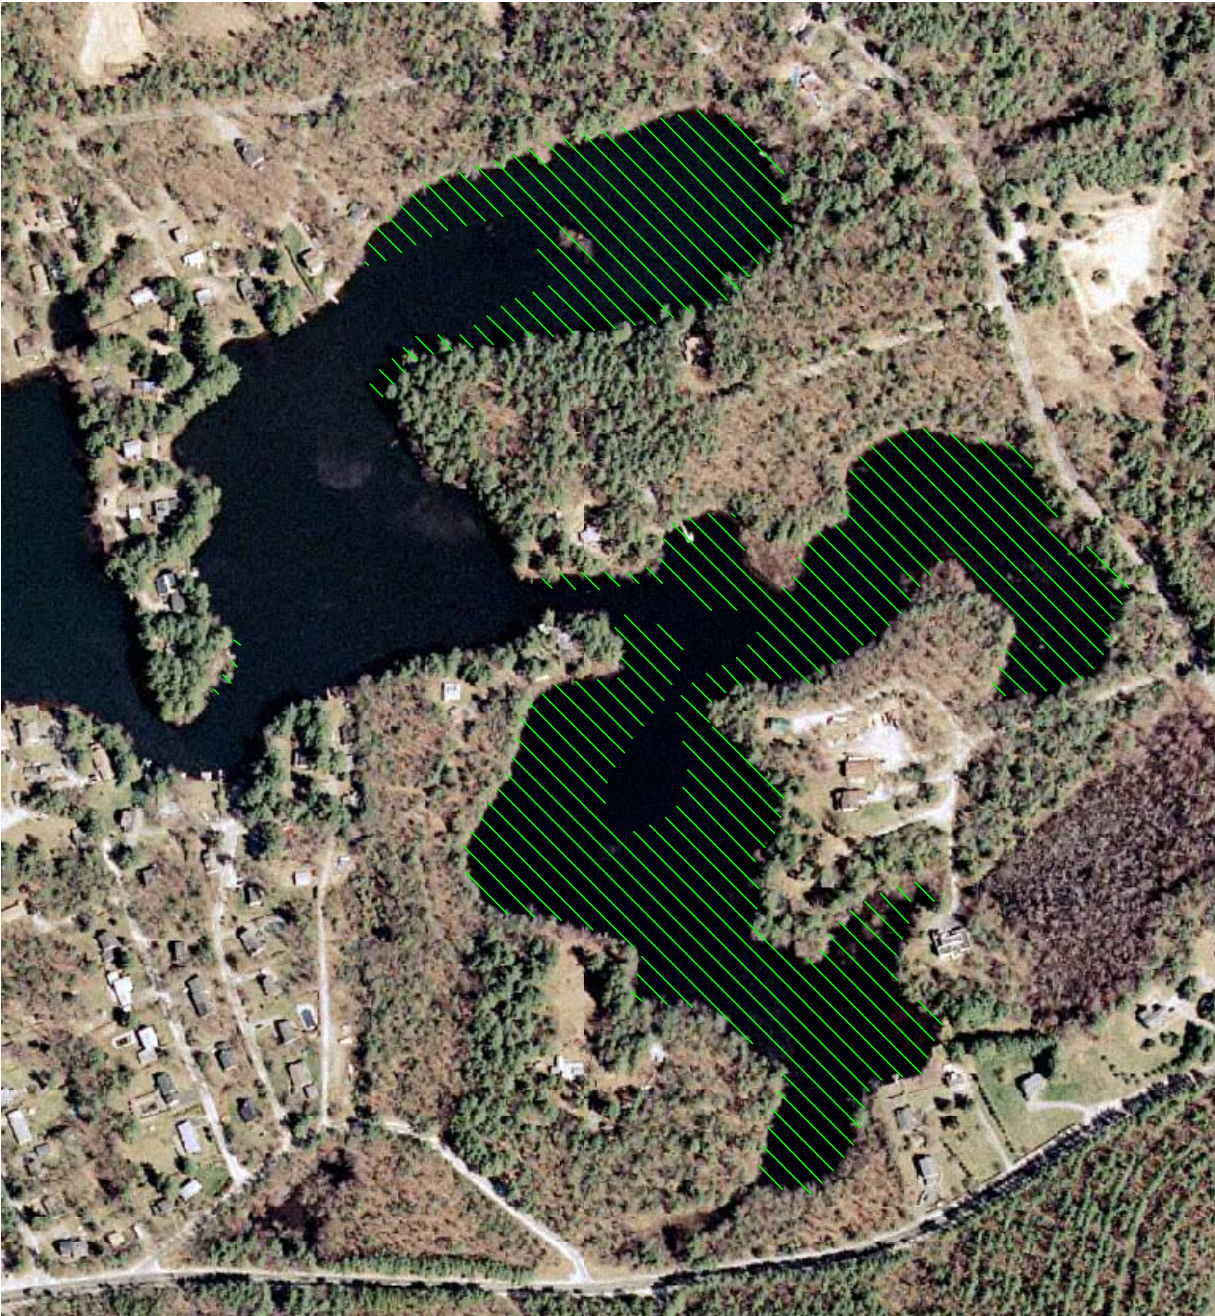
Figure 1. Distribution of floating plants in the eastern basin of Lake Boon. June 2006

<p>Lake Boon Eastern Basin Distribution of Floating Plants (white & yellow pond lilies, watershield, large-leaf pondweed) June 2006</p>

Floating and emergent plant species (i.e., 'canopy' species) identified include watershield (*Brasenia schreberi*), Yellow pond-lily (*Nuphar spp.*), White pond-lily (*Nymphaea spp.*), and the native Large-leaf pondweed (*Potamogeton amplifolius*). *Nuphar*, *Nymphaea* and *Brasenia* vastly outnumber *P.amplifolius* in abundance. Where present in high numbers, these 'canopy' plants tend to be associated with reduced densities of the non-native milfoil and fanwort species.

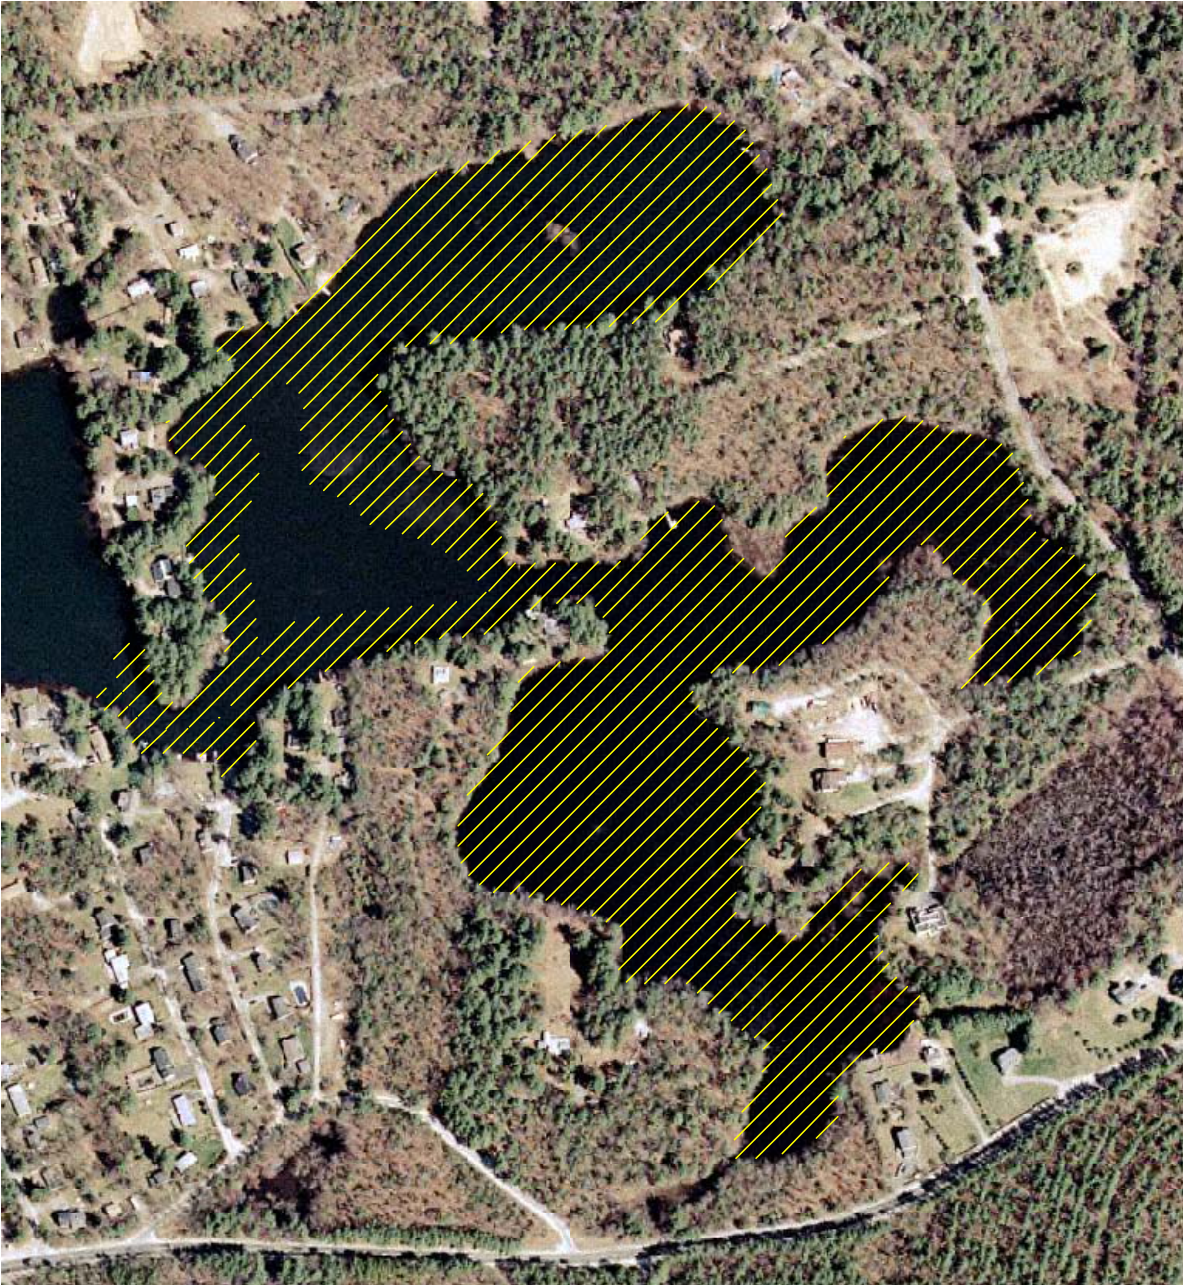
Figure 2. Distribution of Fanwort and Variable-leaf Milfoil in the eastern basin of Lake Boon. June 2006.

<p>Lake Boon Eastern Basin Variable-leaf Milfoil & Fanwort Distribution</p> <p>June 2006</p>

Eastern basin plant-distribution maps are presented in figures 1-4. Variable-leaf Milfoil and fanwort are ubiquitous throughout the eastern basin particularly concentrated in the shallower areas (~8' or less) where together they compose the dominant plant species in the 'understory' of the plant community. Fanwort was found in 4 of the 6 throw-rake samples taken in the middle basin and it is therefore assumed to be present throughout this basin. Milfoil was also present in the middle basin and particularly abundant in a shallow cove with a tributary ca. midway along the southern shore.

Because site 3 is slightly deeper on the northern margin than the other sites it contains *P. robbinsii*. For this reason we suggest using this as the control site. If left untouched, we can monitor if fanwort is invading into the deeper *P. robbinsii* habitat as well as in the shallower areas (e.g. Figure 2).

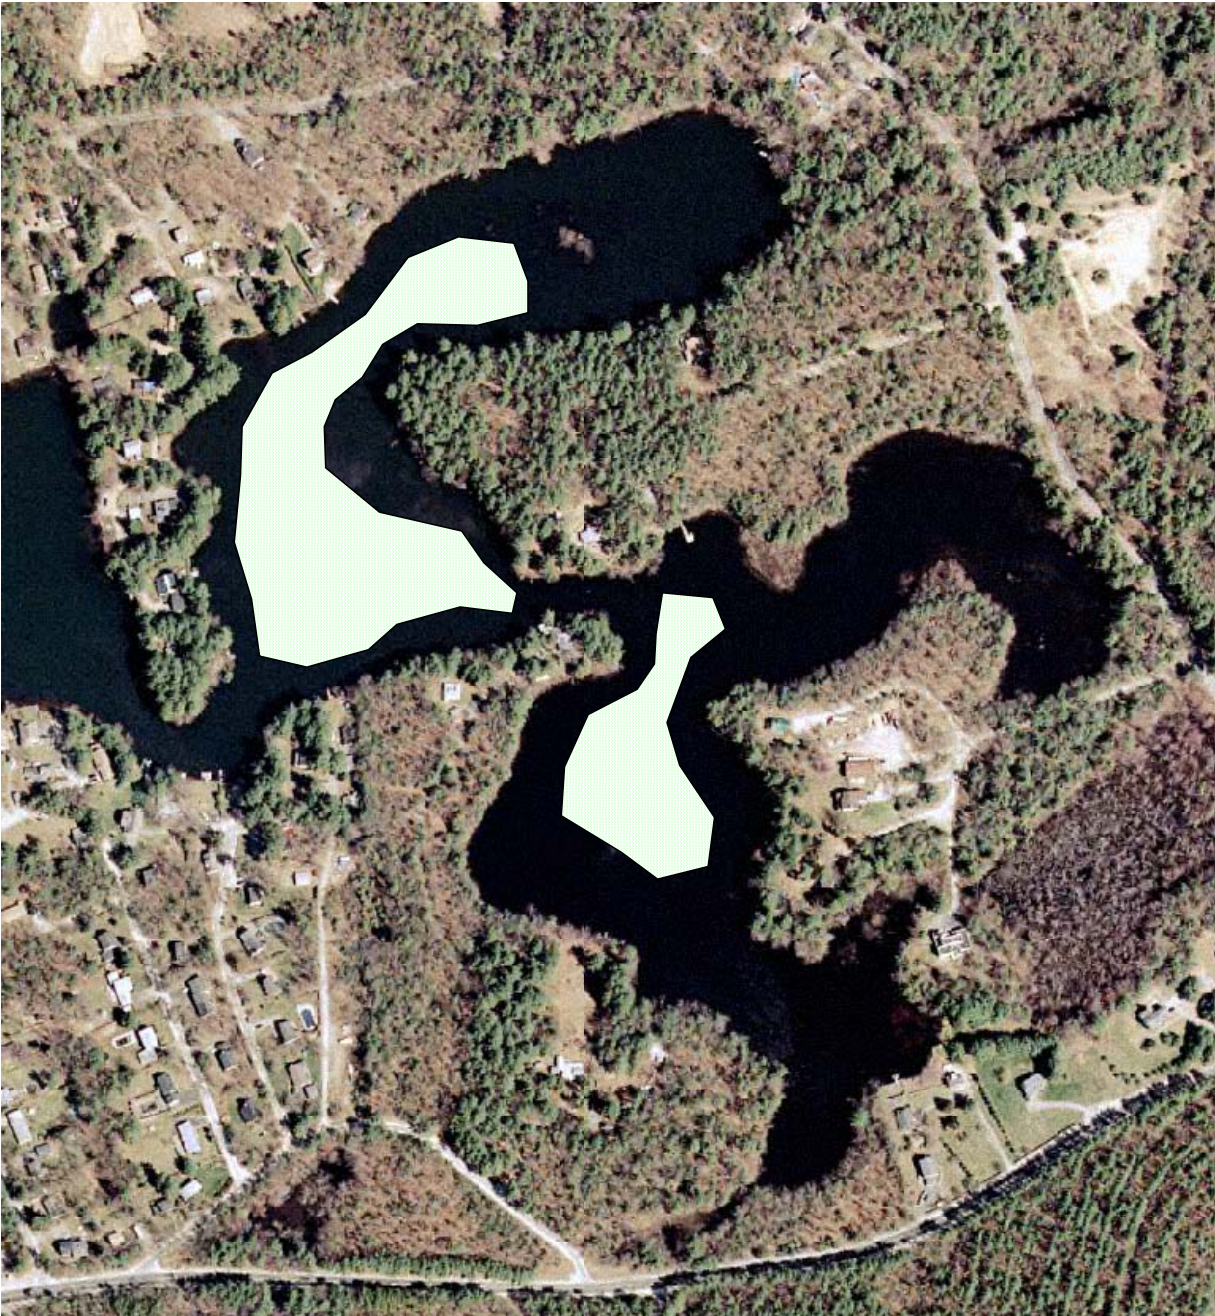
Figure 3. Distribution of *P. robbinsii* in the eastern basin of Lake Boon. June 2006

<p>Lake Boon Eastern Basin <i>P. robbinsii</i> distribution Possible 'take' area for plant replacements June 2006</p>

P. robbinsii was found in relatively deeper waters in the eastern and middle basins. Niads were not seen in the current survey, but may become more abundant as the summer warms and the algal species begin to flourish. Either of these species can serve as replacement plants, though niads may be suitable only for the deeper sections of the study sites.

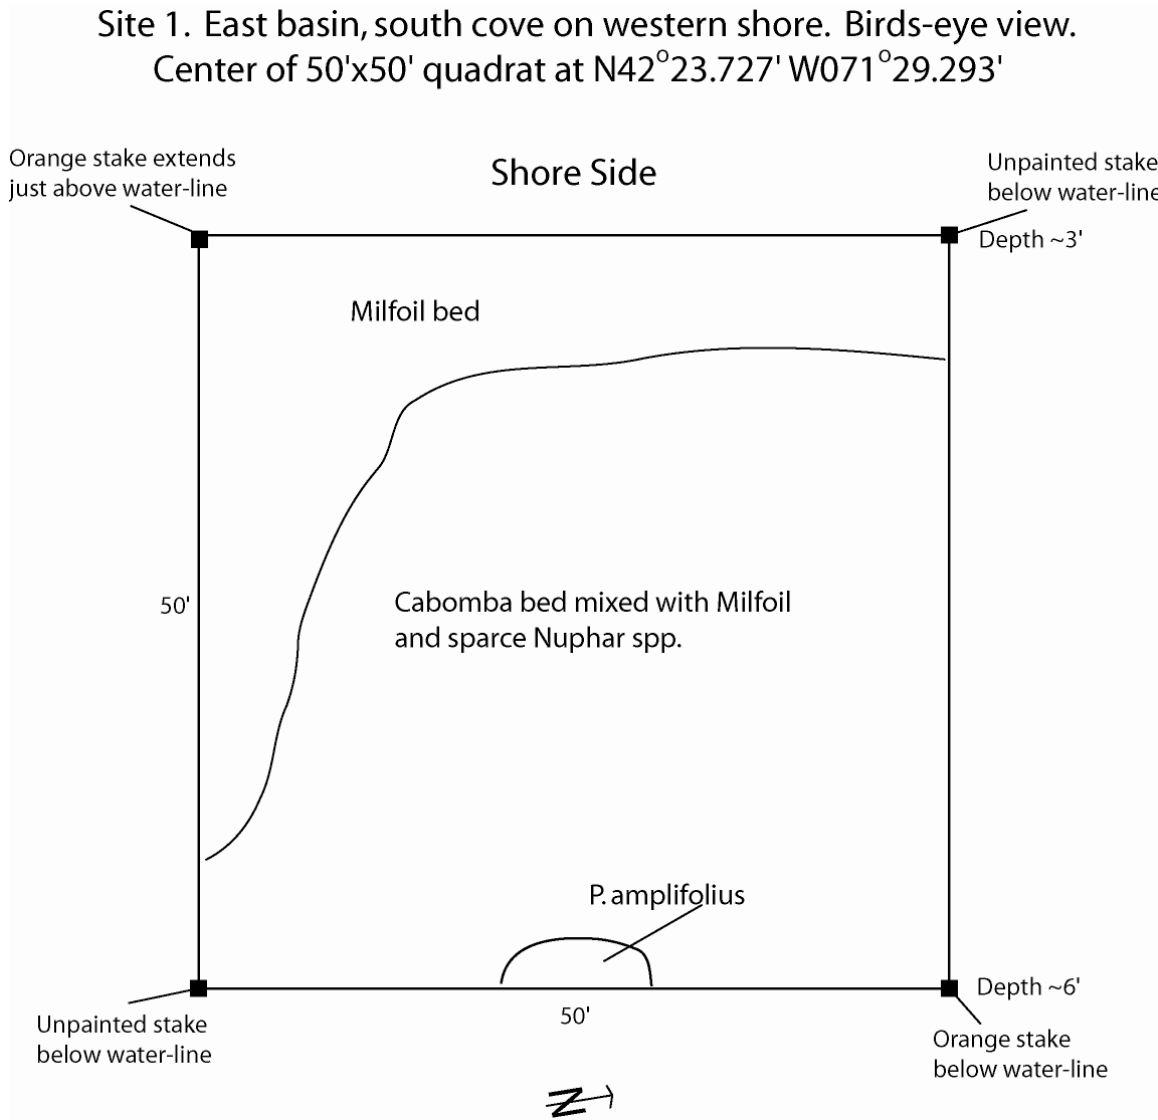
Figure 5. Map of plant distribution in proposed treatment site (site 1) in Lake Boon. June 2006.

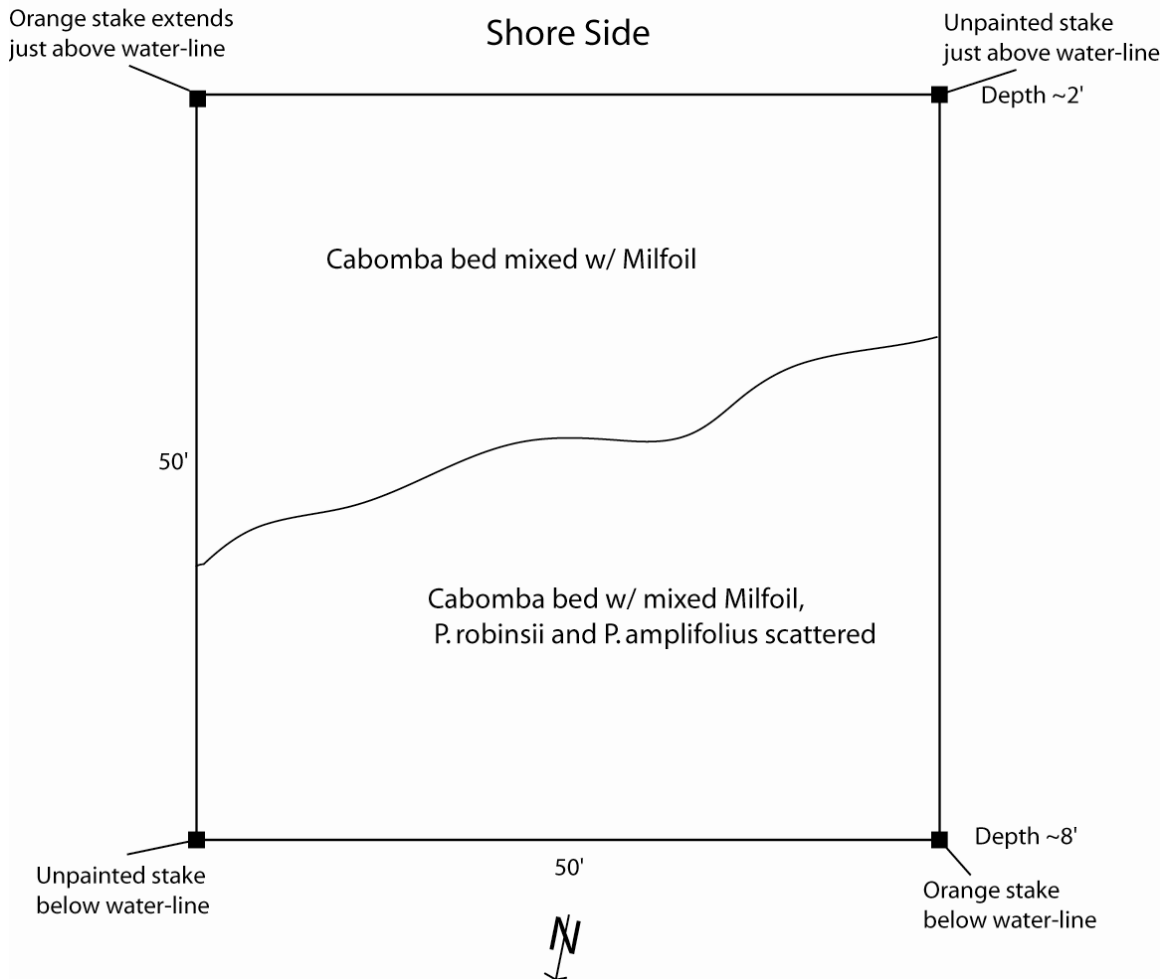
Figure 6. Map of plant distribution in proposed treatment site (site 2) in Lake Boon. June 2006.

Site 2. East basin, northeast cove on southern shore. Birds-eye view.
Center of 50'x50' quadrat at $N42^{\circ}23.869'$ $W071^{\circ}29.328'$

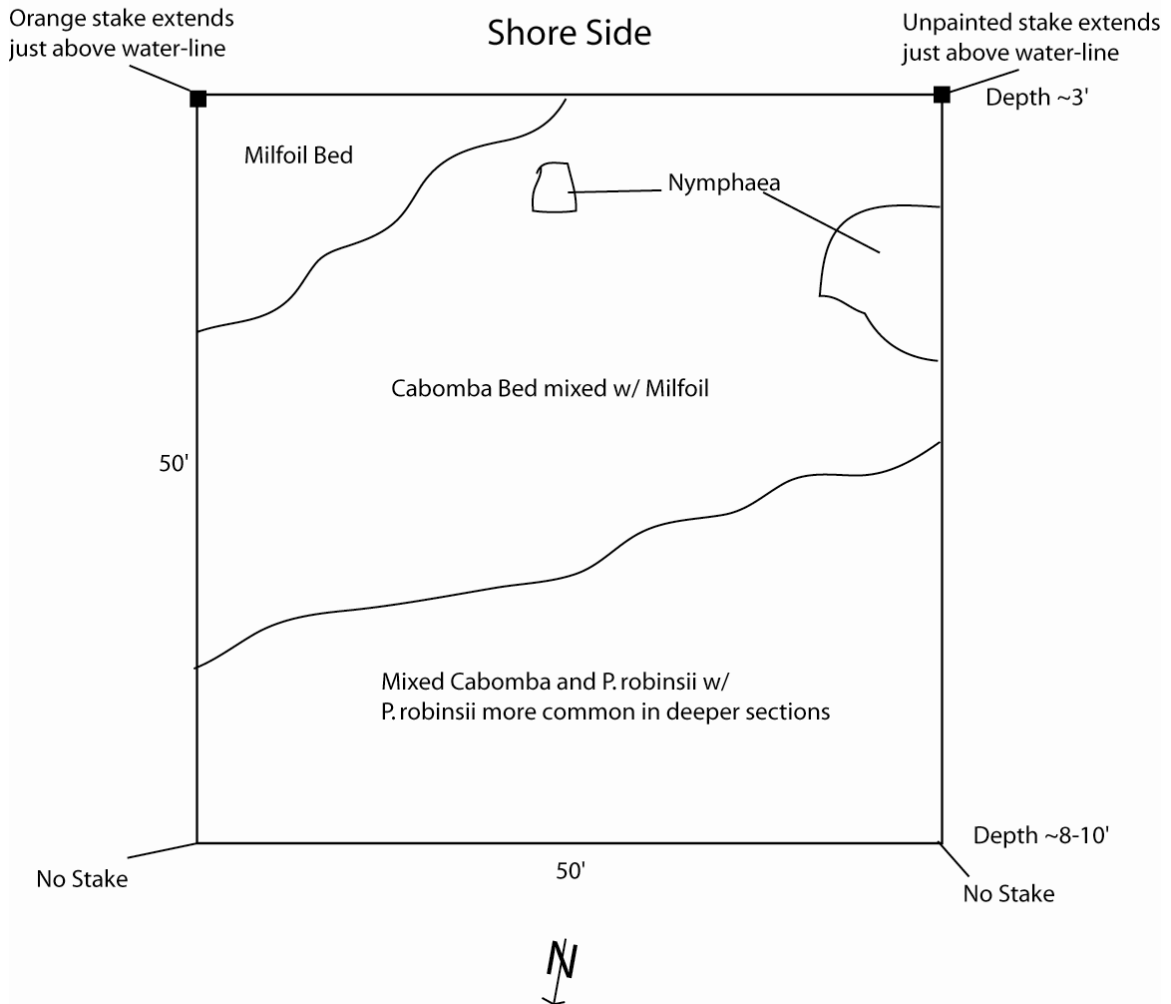
Figure 7. Map of plant distribution in proposed control site (site 3) in Lake Boon. June 2006.

Site 3. East basin, deep bay on southern shore. Birds-eye view.
Center of 50'x50' quadrat at N42°23.752' W071°29.370'

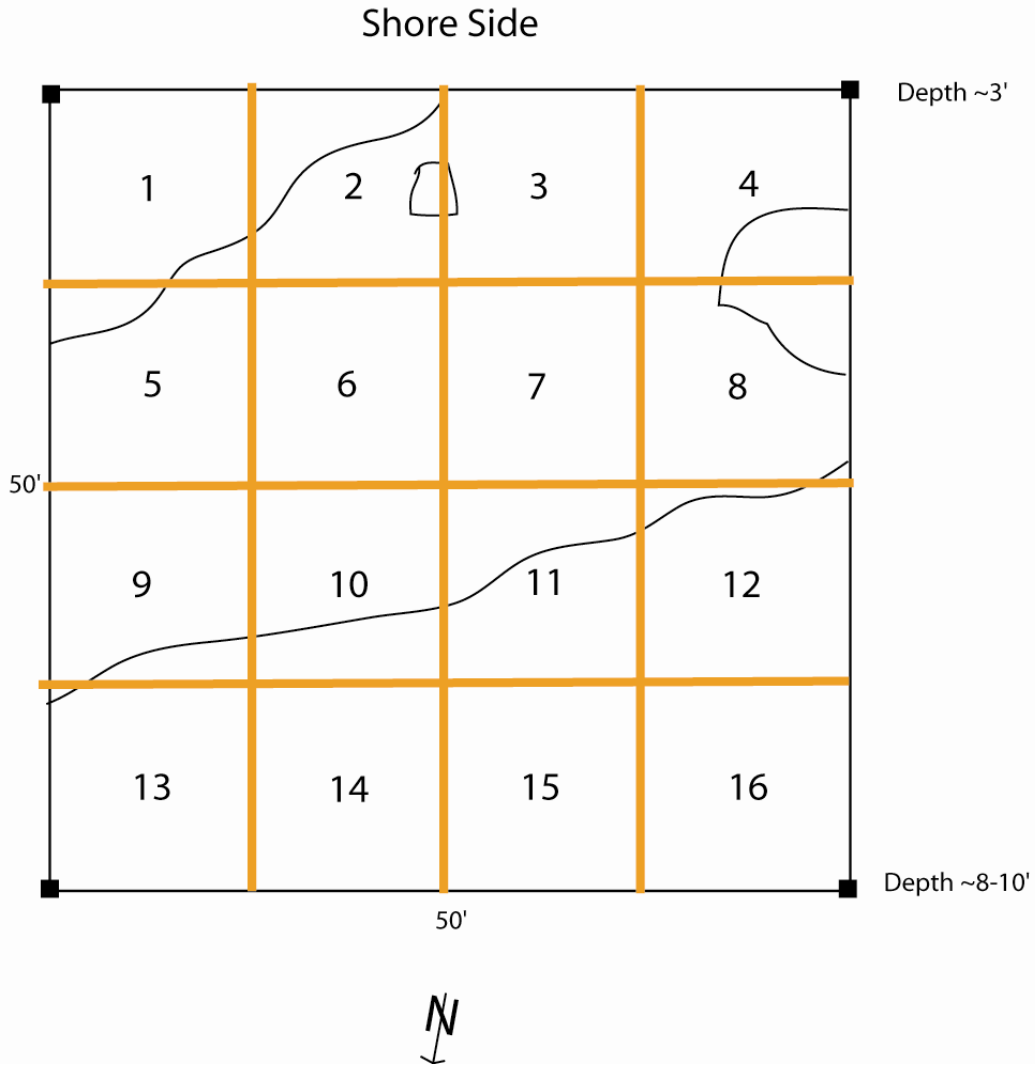
Figure 8. Sample grid overlay on site 3 vegetation map.

Sample grid overlay on quadrats. Birds-eye view.

In order to aid mapping of the control and treatment sites, a 4 x 4 grid will be installed in each of the three sites (Figure 8). The grid will be constructed of a thin, yellow, nylon rope which will be secured to the substrate with small metal staples and/or cement blocks. The grids will divide the 50' x 50' area into 16, 12.5' x 12.5' areas. Greater mapping detail can be obtained using this approach, particularly so in the dark water of Lake Boon where diver visibility is limited.

A grid will be installed in the control site the same time the benthic barrier panels are installed in the treatment sites (should this approach be acceptable). Once the barrier panels are removed from the treatment sites, grids will be installed prior to plant replacement. Thus, accurate maps can be made of the newly planted areas as well.
