AQUATIC PLANT MANAGEMENT  
LAKE BOON  
STOW/HUDSON, MASSACHUSETTS  
BIOLOGICAL SURVEY REPORT  
September 2006

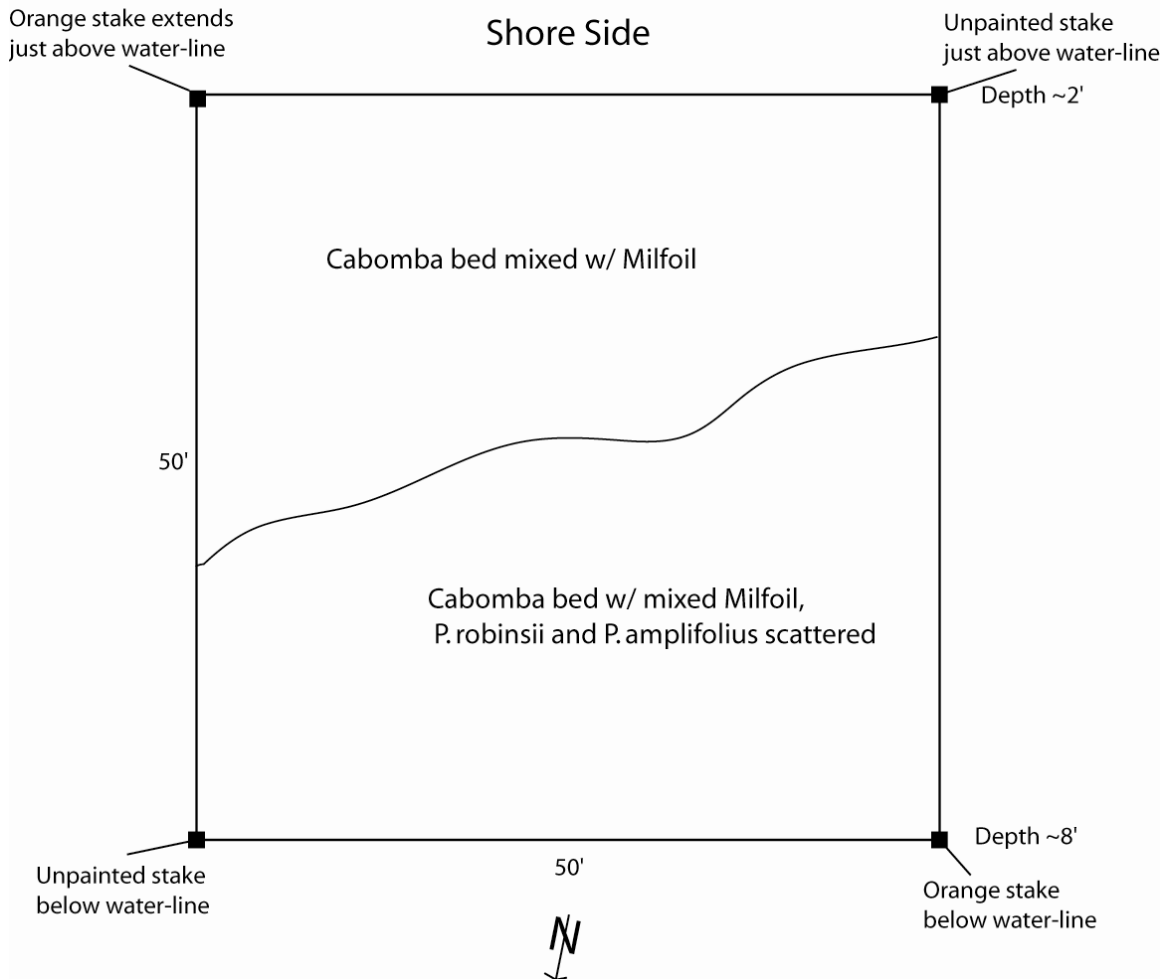
Figure 3. Map of plant distribution in proposed treatment site 2 in Lake Boon.

Site 2. East basin, northeast cove on southern shore. Birds-eye view.  
Center of 50'x50' quadrat at  $N42^{\circ}23.869'$   $W071^{\circ}29.328'$

The benthic barrier was very effective at eliminating plants in site 2, but was not as effective at site 1. As a result, not all 16 cells were available for replanting at site 1. Nonetheless, we believe enough of the area was cleared that the study could continue as planned. However, visibility is very limited at site one and dense algal growth remains over the study area.

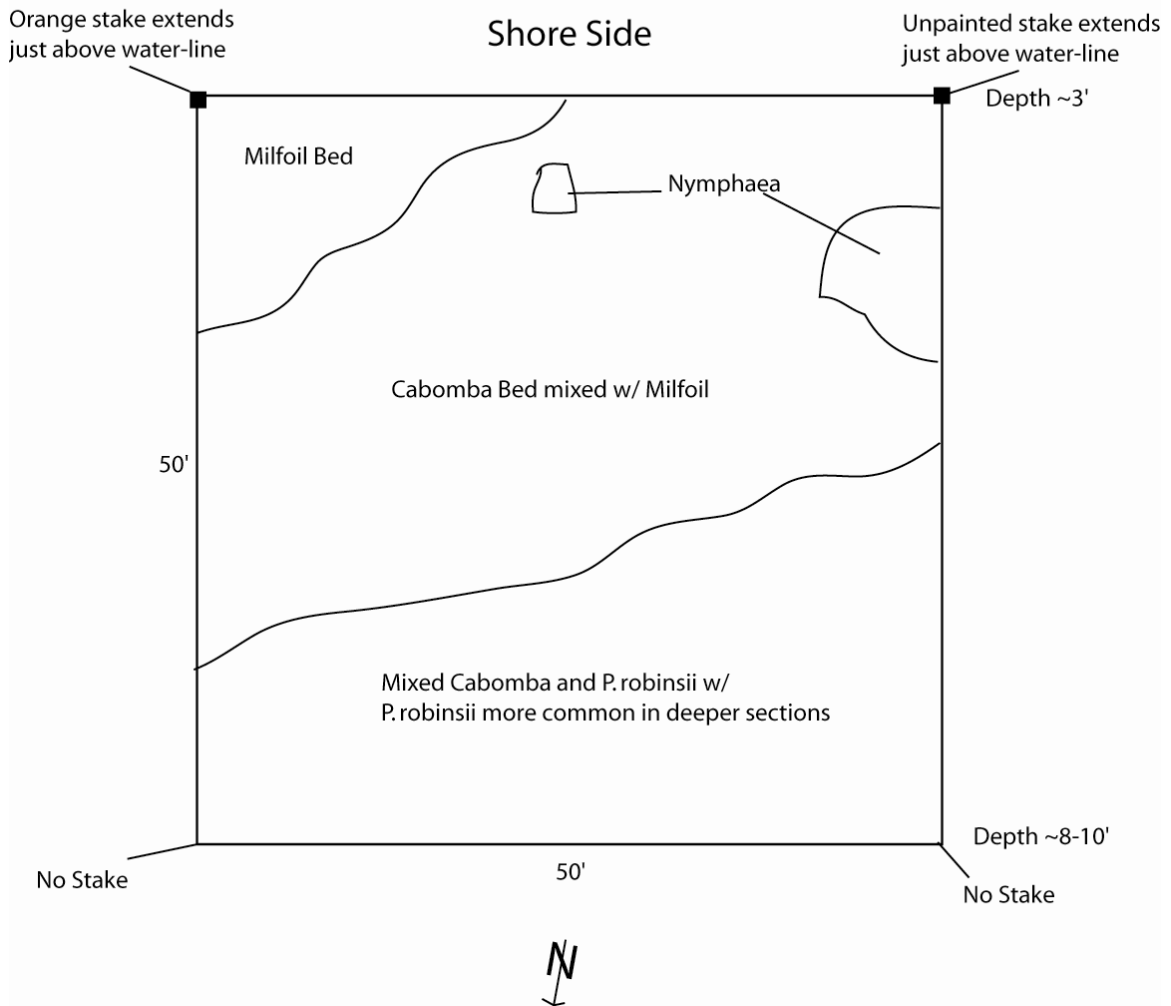
Figure 4. Map of plant distribution in proposed control site 3 in Lake Boon.

Site 3. East basin, deep bay on southern shore. Birds-eye view.  
Center of 50'x50' quadrat at N42°23.752' W071°29.370'

At the control site, plant distributions were similar to that observed in June 2006. However, the individual species densities had changed at this site between June and September 2006. *C. carolinia* (fanwort) was more common in all cells in the later survey. Fanwort largely displaced the milfoil that was originally in the shallower areas and also extended further into the deeper section of the lake beyond the quadrat.
