AQUATIC PLANT MANAGEMENT  
LAKE BOON  
STOW/HUDSON, MASSACHUSETTS  
PLANT CONTROL STUDY DRAFT REPORT  
May 2007

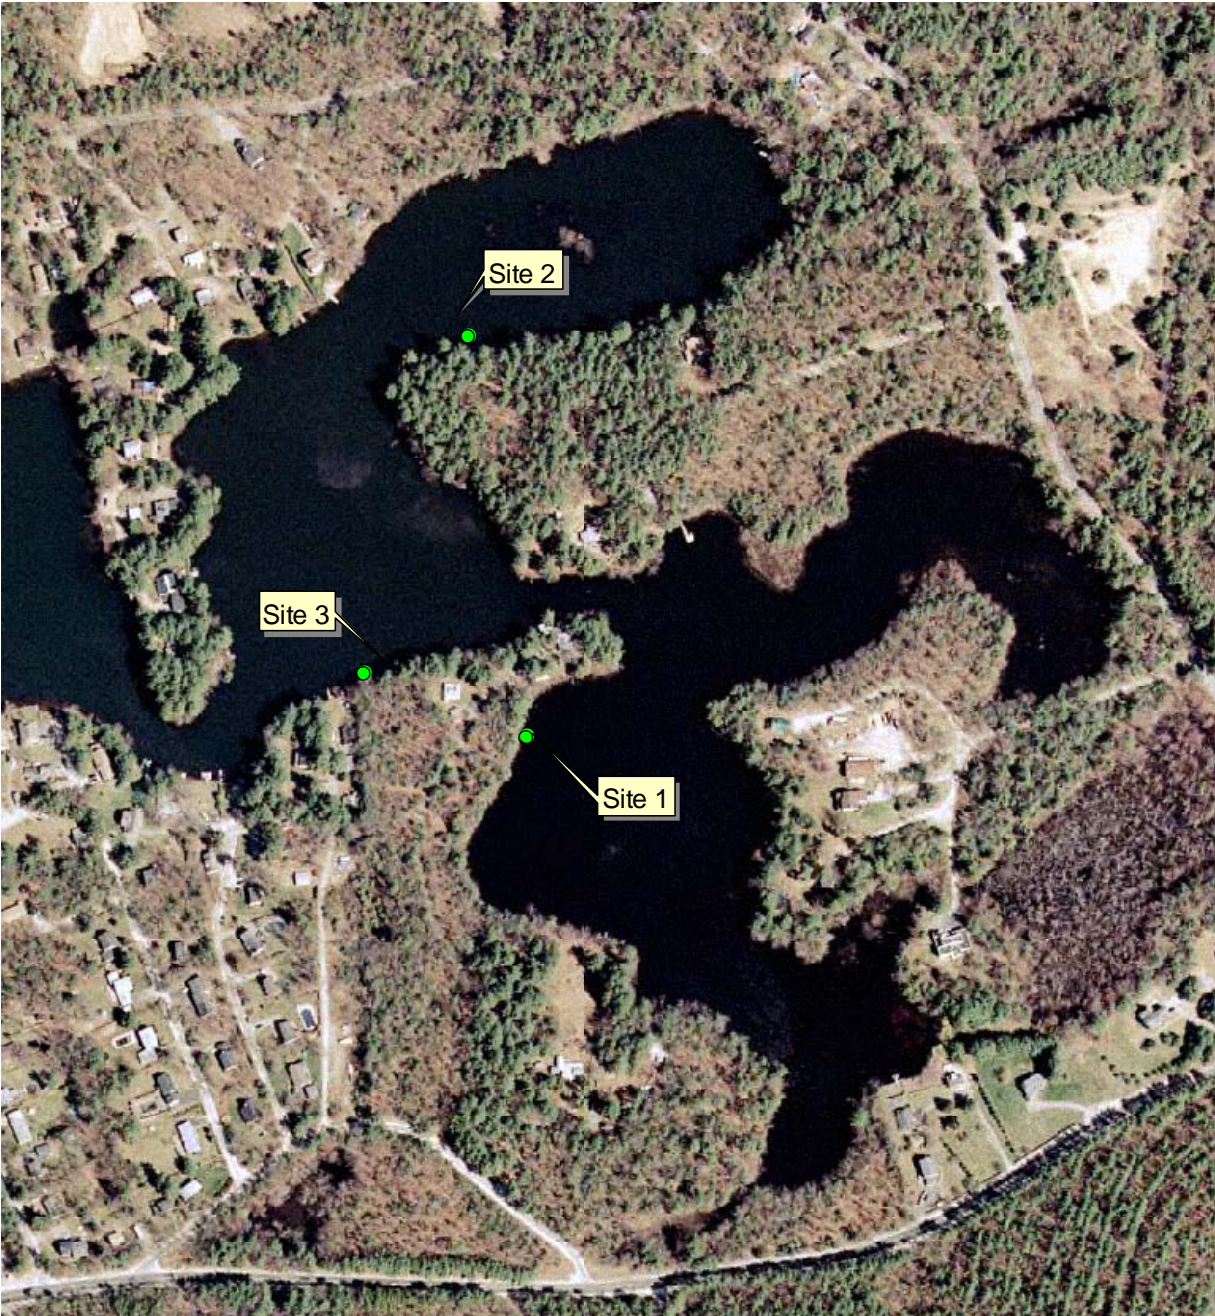
Figure 1. Study site locations.

<p><b>Lake Boon</b> <b>Eastern Basin</b> Proposed control and plant removal sites  June 2006</p>

Three sites were chosen for study (Figure 1). Sites 1 and 2 were treatment areas and Site 3 was a control. Sites 1 and 2 had all plants removed within the 50' x 50' area by use of benthic barrier panels. Panels were installed in June 2006 and removed in September 2006. After barrier removal at Site 1 plant species were allowed to recolonize without further intervention in an attempt to monitor the effect of removal without replacement. Because of the problems with visibility ( $vis=0$ ) at this site all usable cells here were assigned a replanting density of Zero (i.e., removal without replacement). After barrier removal at Site 2 nearly 200 *P. robbinsii* plants were transplanted within the grid system in an attempt to monitor the effect of plant removal (primarily *C. carolinia*) and replacement with a local (Lake Boon) native species. Each cell of the Site 2 grid was randomly assigned a density of Zero, Low ( $n=10$ ), or High ( $n=25$ ). This method was used in hopes that any density dependent factors regarding our transplanting study would be apparent. That is to say, our hope was that if transplanting was successful we could determine an optimal density of native plants to use so as to be more efficient with any larger-scale transplanting study/project within Lake Boon. After the initial transplanting, follow up surveys at Site 2 in the fall of 2006 found *P. robbinsii* still in place.

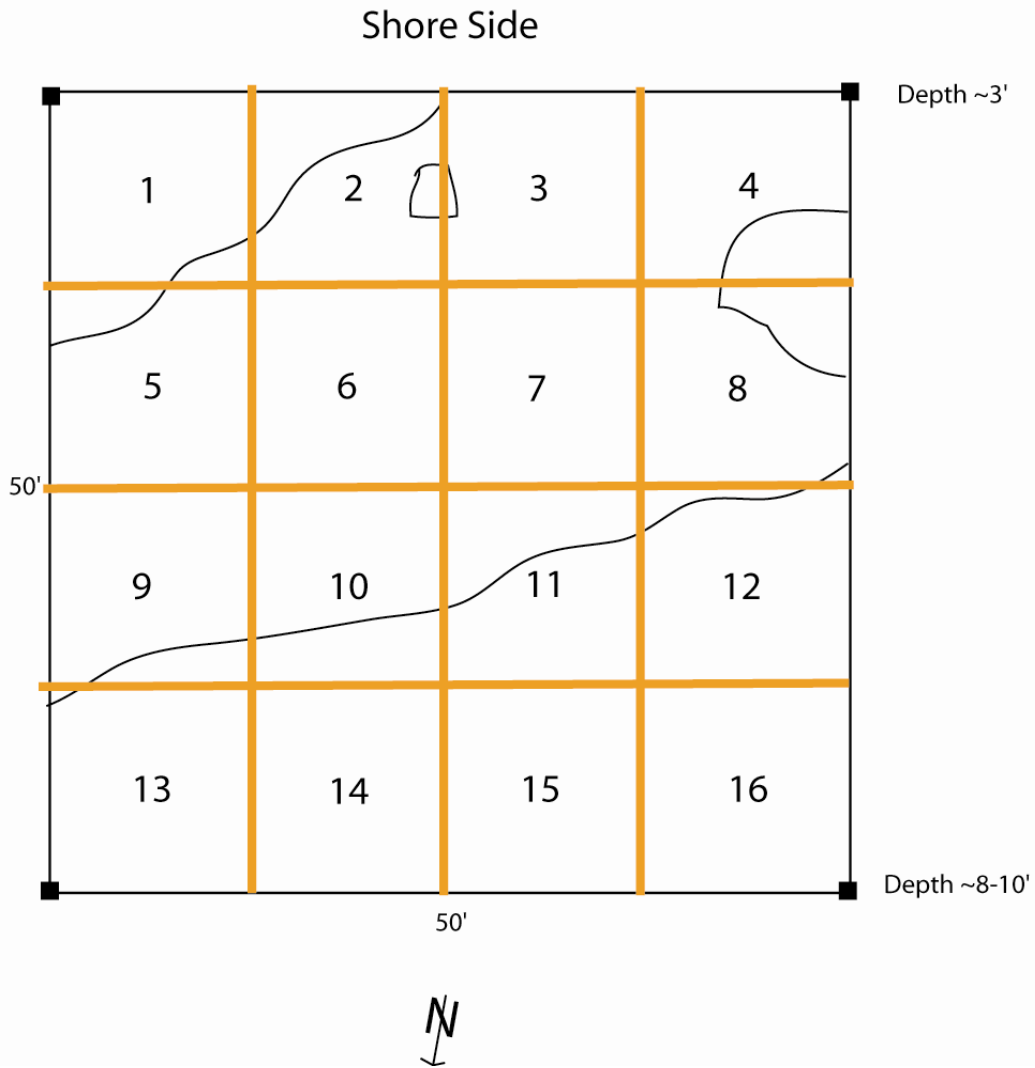
Figure 5. Grid overlay on Site 3, 2006 vegetation map.

Sample grid overlay on quadrats. Birds-eye view.

A submerged rope grid was installed at each site in September 2006 after barrier removal, but before transplanting in order to map the replanting, re-growth and/or reinvasion of any plant species. Study grids had the overall dimensions of 50' x 50' with 16 cells of 12.5' x 12.5' in each (Figure 5). All plant species originally present within the study areas
